Technical Report OPS 89-11

**ELECTRIC RESISTANCE WELD PIPE FAILURES
ON HAZARDOUS LIQUID AND GAS TRANSMISSION PIPELINES**

AUGUST 1989

**Office of Pipeline Safety
Research and Special Programs Administration
U.S. Department of Transportation**

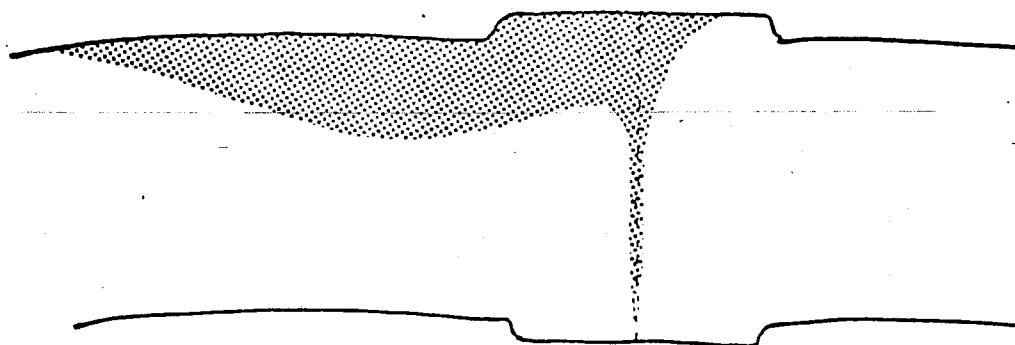
Figure B-4

Sketch based on evidence indicated by Figures B-1, B-2, and B-3 illustrating how localized corrosion (corroded areas shown by dots) along the flash weld extended across the wall and developed a deep narrow groove that had the effect of a crack with sufficient depth and length to initiate the failure.
